# Manhole Inspection Summary

Manhole # S31WW1006MH

**Location** Address: **101 UPNOR RD**

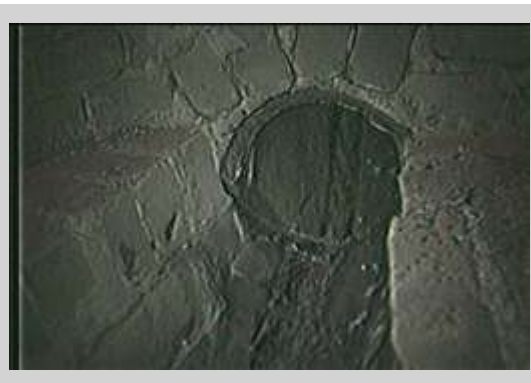
### Drop In @ 3 O'Clock

Drop: **Outside** Rod and Bar

Angled: **Yes** Reading: **12.12** (ft.)

Drop Condition: **Open**
